# CROSS

## Confidential Reporting on Structural Safety

### Newsletter No 14, April 2009

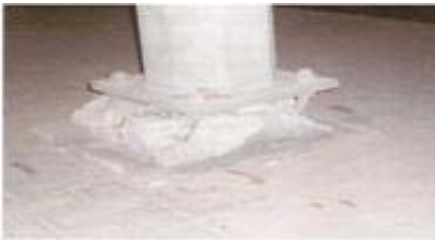
An overseas reporter says that majority of street light poles and advertisement board bases in his location are not constructed to the proper standard of safe practice for structural engineering and this creates a potential source of accidents. Errors include inadequate minimum edge distance between concrete face and bolt centres, no grout between base plate and foundations, and no protection to the bolts and base plates. The reporter believes these could affect the safety of road users.

improperly installed and damaged base

**CROSS comments:** *Design and construction standards for new street lighting columns have been in use for several years, but older structures still exist and it is probably these which are the subject of UK press reports. In one town more than 500 lamp-posts were deemed to be unsafe and a survey of lamp-posts in another found that they were suffering "structural failure", where more than half have been eroded by rain and dogs. SCOSS drew attention to the problems of aging lighting columns in section 3.6 of their [Report 12](#) in 1999. Ten percent of the 6.5m lighting columns in the UK were estimated to be in urgent need of repair or replacement. Steel columns can suffer from fatigue due to wind oscillation, and by the seaside even galvanised post have a very finite life. Corroded lamp posts in particular pose a big risk if they are hit by a vehicle and potentially unsafe columns should be reported to local authority Highways Departments. (Reports 098 and 114)*

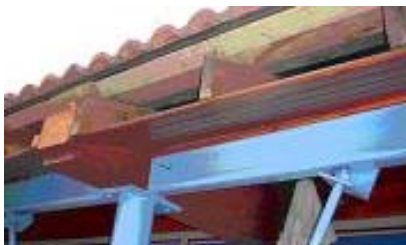
the fallen fascia

end grain of rafters

inadequate nailing

A section of pressed steel gutter and plywood fascia board at a school collapsed during or after a heavy rainstorm. The reporter believes that it had been in service for 15 to 20 years. He understands that staff and pupils had walked beneath the failed gutter just minutes before its collapse, narrowly avoiding a serious accident. The gutter was about 200 mm wide x 250 mm deep. He believes that the down pipe may have become blocked, allowing the gutter to fill during heavy rain. The method of fixing the gutter and plywood fascia board was simply by nailing into the end grain of the rafters, which are at 600 mm centres. Inspection by the reporter revealed that there was no other support. BS 5268 cl 6.4.4.3 states that 'no withdrawal load should be carried by a nail driven into the end grain of timber'. He therefore regards this fixing detail as inadequate and potentially dangerous and is concerned that the detail might have been used on other institutional buildings.

**CROSS comments:** *CROSS has previously had reports concerning failures at schools including a brickwork cladding panel collapse (Report No 078 Newsletter No 8, October 2007), and the collapse of internal wall due to wind load during construction (Report No 099 Newsletter No 10, April 2008). This is another example of a collapse that could have had tragic consequences and the question might be raised as to whether the standards at schools differ from those in other buildings. Apparently trivial details may not receive proper engineering attention but are nevertheless vital. All building work needs to be 'robust'. (Report 137)*

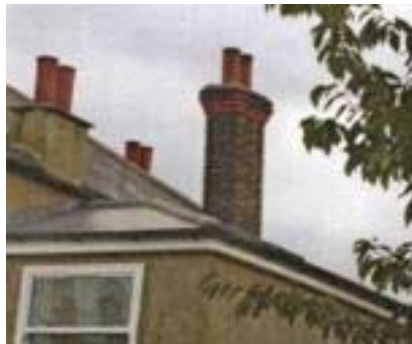
During the refurbishment of an Edwardian single family dwelling a reporter found that the supporting chimney breasts had been removed and replaced with inadequate gallows brackets in the roof space above eaves level. The substantial 2.5m high chimney stack was left almost unsupported and in a potentially dangerous state.

unsupported chimney

**CROSS comments:** *Many building control officers will be familiar with cases such as this where the structural significance of a masonry component has been ignored and there is a risk of consequential collapse. Deterioration of the exposed mortar over time, high wind loads, or even a very minor seismic shock could topple the chimney and deposit several tonnes of debris into the house. This illustrates the need for competence and supports the view that any structural alteration works should be assessed by a structural engineer. (Report 131)*

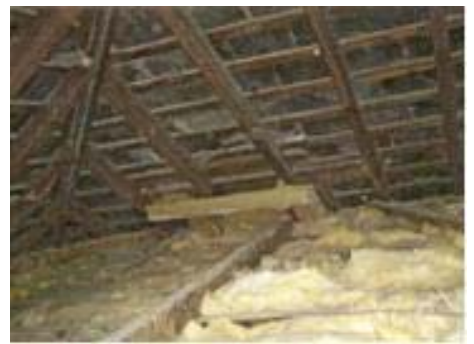
roof space with chimney breast removed
